U.S. Air Force Airfield Damage Repair (ADR) Modernization Program

Large Crater Repair at Silver Flag Exercise Site, Tyndall Air Force Base, Florida

August 2015

Final report

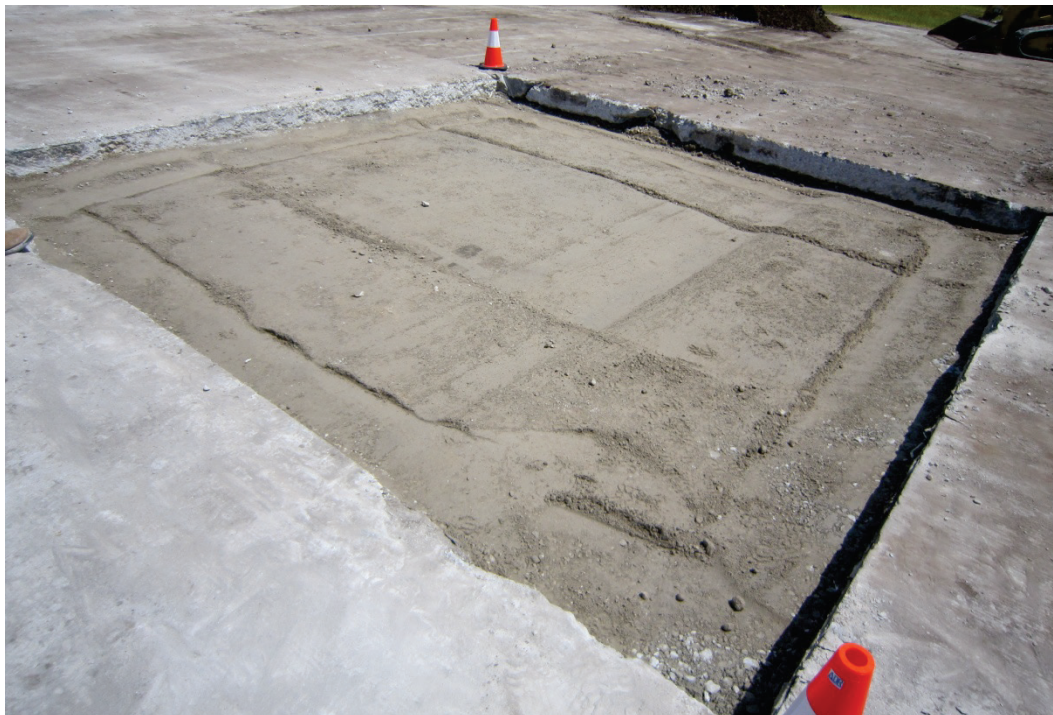
Figure 44. Completed crushed stone backfill - Training Crater 1.

Placement and compaction of crushed stone backfill took 45 min to complete for Training Crater 1. Primary compaction was performed with the CTL roller attachment, and the edge of the excavation was compacted with the smaller plate compactor. Figure 44 displays the completed crushed limestone backfill of Training Crater 1.

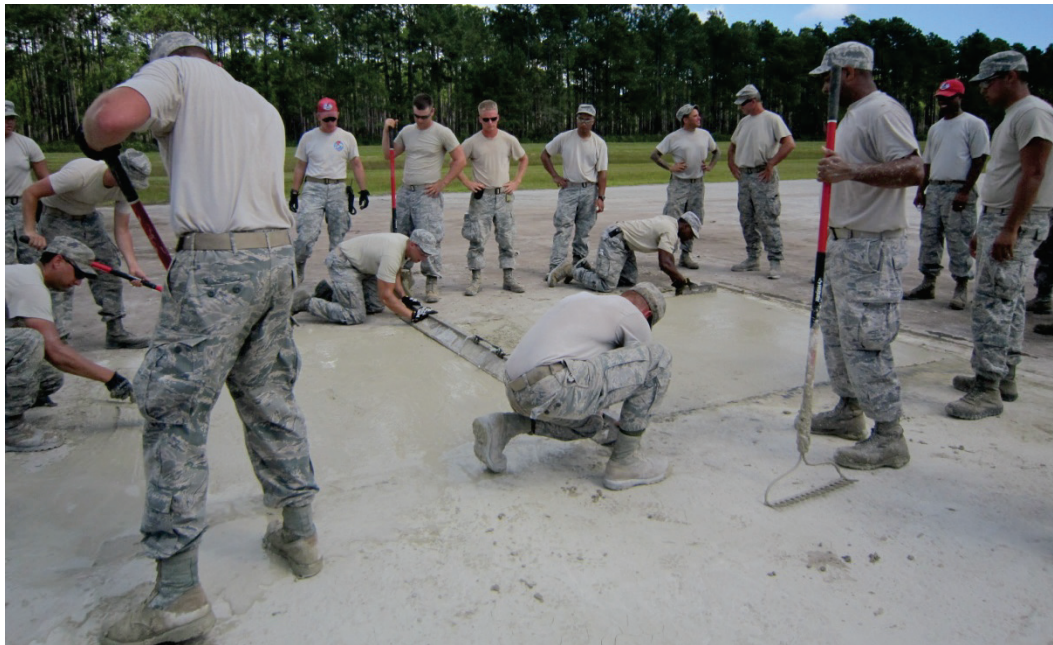
Figure 45. Capping of Training Crater 1.

Capping with rapid-setting concrete took approximately 1 hr. The first half of the repair, separated using the form boards, was placed and screeded. After the rapid-setting concrete had achieved initial set, the form was stripped, and the other half of the cap was placed (Figure 45).

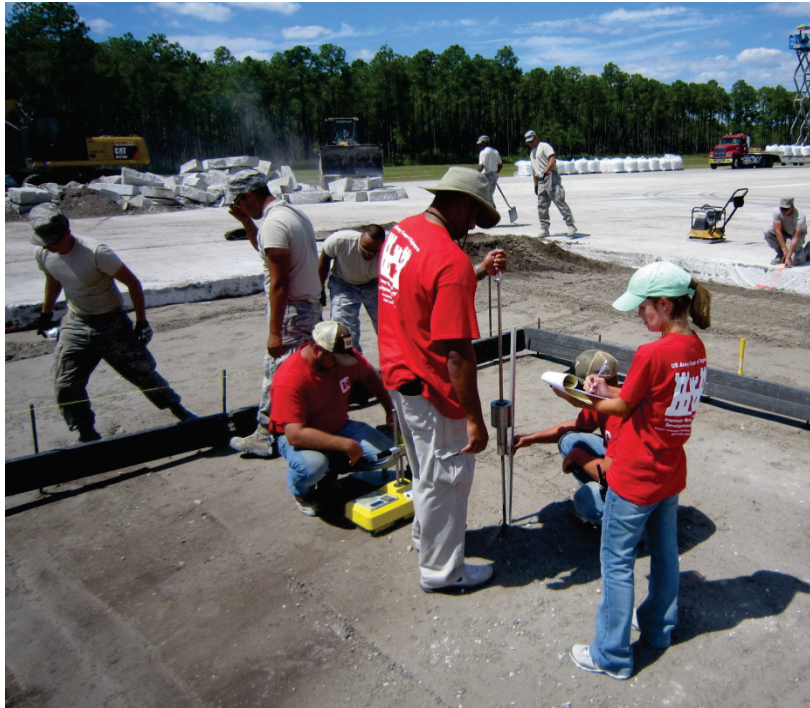
Figure 51. Crushed stone backfill data collection.

Nuclear moisture and density tests (ASTM D3017 and D6938) and DCP tests (ASTM D6951) were conducted on the crushed stone backfill layer of Crater 1 during construction as shown in Figure 51. Additional DCP testing was also conducted on the backfill after core holes were drilled to sample the concrete cap the day after testing. Table 9 contains the in-situ properties obtained from this testing for Crater 1. The dry densities obtained were lower than typical for crushed limestone (135 to 140 lbf/ft³). The material was exposed to open air and had a relatively high moisture content of 14.1 %, which contributed to the lower density values. The optimum moisture content for crushed stone material for pavement base courses is typically closer to 4% according to Webster (1993). Also, since conventional compaction equipment (vibratory steel wheeled rollers) is too cumbersome to use for crater repair, the alternate equipment used (CV18 roller attachment) likely produced less compactive energy than conventional compaction equipment. The CBR values were also slightly lower than expected. Typically, well-compacted crushed stone can produce values of 80 to 100 CBR a few days after construction if the moisture content is near optimum, but the average value after construction was 45 CBR for Crater 1. However, the crushed stone backfill exceeded the strength requirement (> 25 CBR) for a subbase under rigid pavement and was acceptable for use as a backfill layer under rapid-setting concrete.

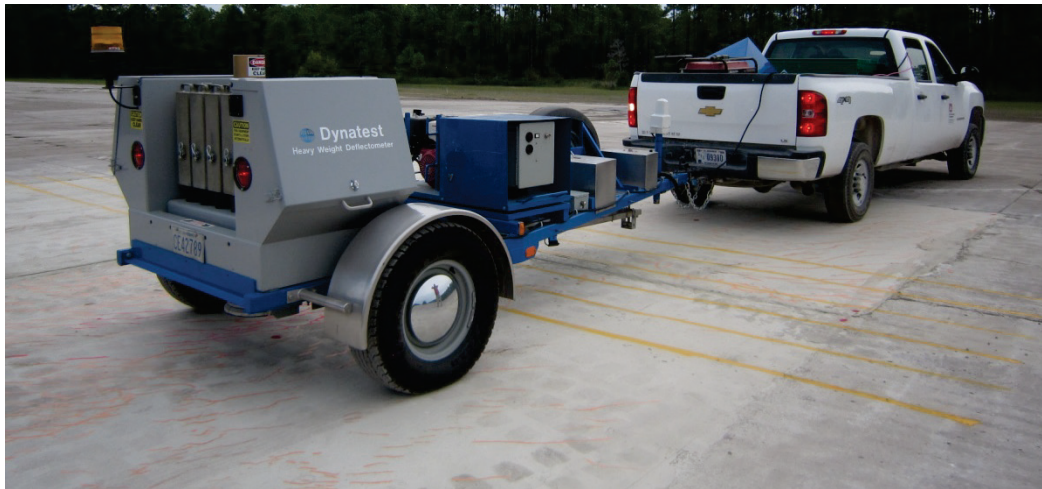
Figure 52. HWD testing on repaired crater.

The HWD was employed to collect the impulse stiffness modulus (ISM) of each repaired crater (Figure 52). One test was performed on each quadrant, and the results were averaged for each crater repair. A control test was also performed on one parent slab on site before each set of HWD testing.

The ISM data from the HWD is plotted for each crater at each pass level in Figure 53. The ISMs before trafficking are considerably lower than those reported by Edwards et al. (2013) and Bell et al. (2013). Typically the ISMs for the rapid-setting concrete are between 3,500 and 4,500 kips/in. However, the measured ISMs collected at the 0 pass level ranged between 2,181 and 2,661 kips/in. The HWD data contradicts the compressive strength data discussed in Section 5.4.4, which showed that each quadrant of each crater repair exceeded the required 28-day compressive strength. For Crater 1, data was collected only at 0 and 100 passes, and the ISM increased slightly between those two intervals. Crater 2 showed a slight increase between 0 and 100 passes and then a considerable drop at 900 and 1,500 passes, as the crater repair began to fail under traffic. The ISM for Crater 3 generally remained the same until dropping moderately at 1,500 passes. The control test point showed that the PCC slab stiffness generally remained consistent. Overall, the stiffness of the repairs was generally as high or higher than the control slab, until accumulating damage from traffic.

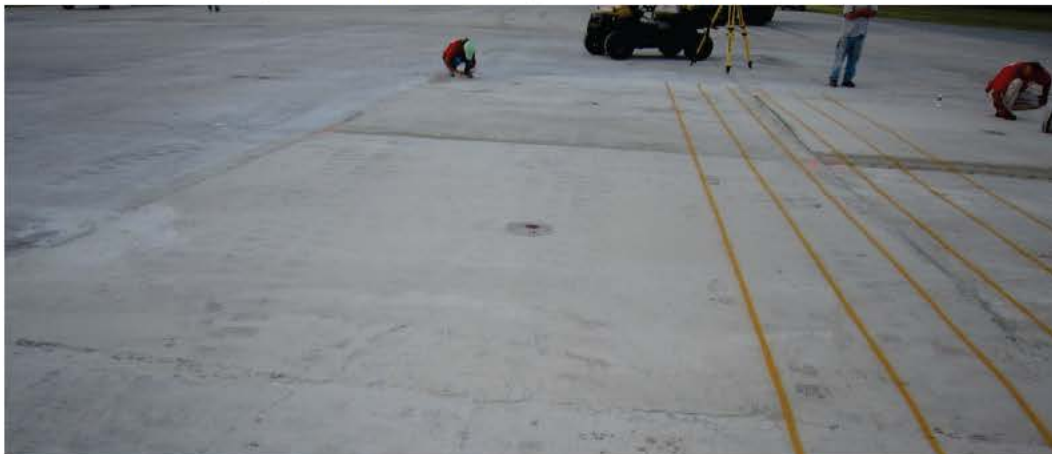
FOD debris removal team entered the northeast quadrant before final set was obtained, resulting in the row of track imprints, shown as the horizontal dark area in Figure 55. The plastic joint board cap on one of the quadrants was removed before final set, resulting in a small spall that ran the length of the west edge of the northeast quadrant. The small shrinkage cracks were caused by a concrete mix that contained excess water. Even a small amount of water will typically migrate to the top of the concrete cap during placement and can lead to shrinkage cracking. The variability in the concrete mix was caused by the diesel engine of the simplified volumetric mixer suddenly shutting down in several instances, to the point where a second simplified volumetric mixer was employed.

Figure 55. Crater 1, east quadrants, finished repair.

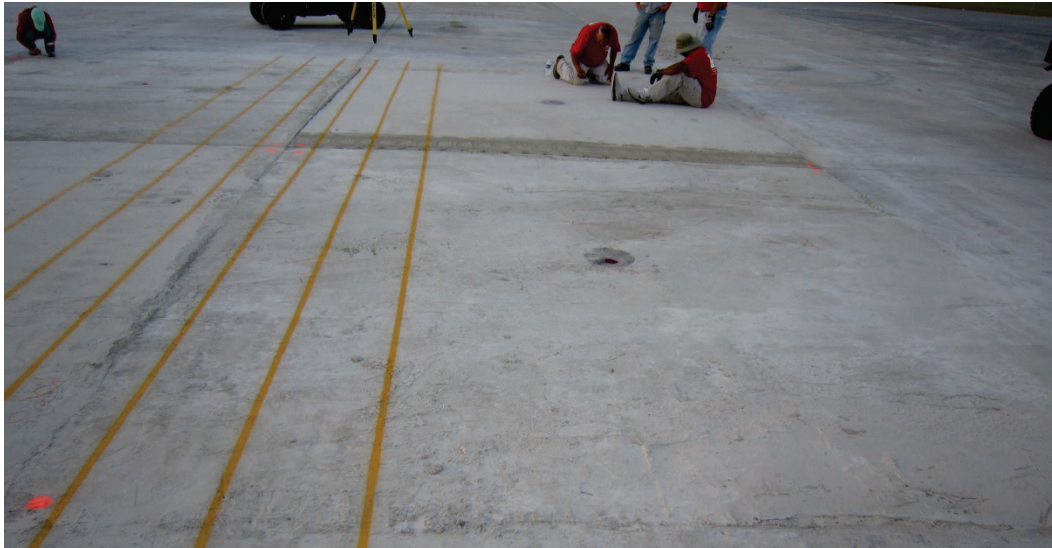
Figure 56 shows the west quadrants of Crater 2 after repair. Some shrinkage cracks (highlighted in orange) and small surface defects were noted. Figure 57 shows the east quadrants of Crater 2. Both quadrants exhibited shrinkage cracking, and the northeast quadrant contained considerably more than the southeast quadrant. Overall, the finish of Crater 2 was much smoother than Crater 1.

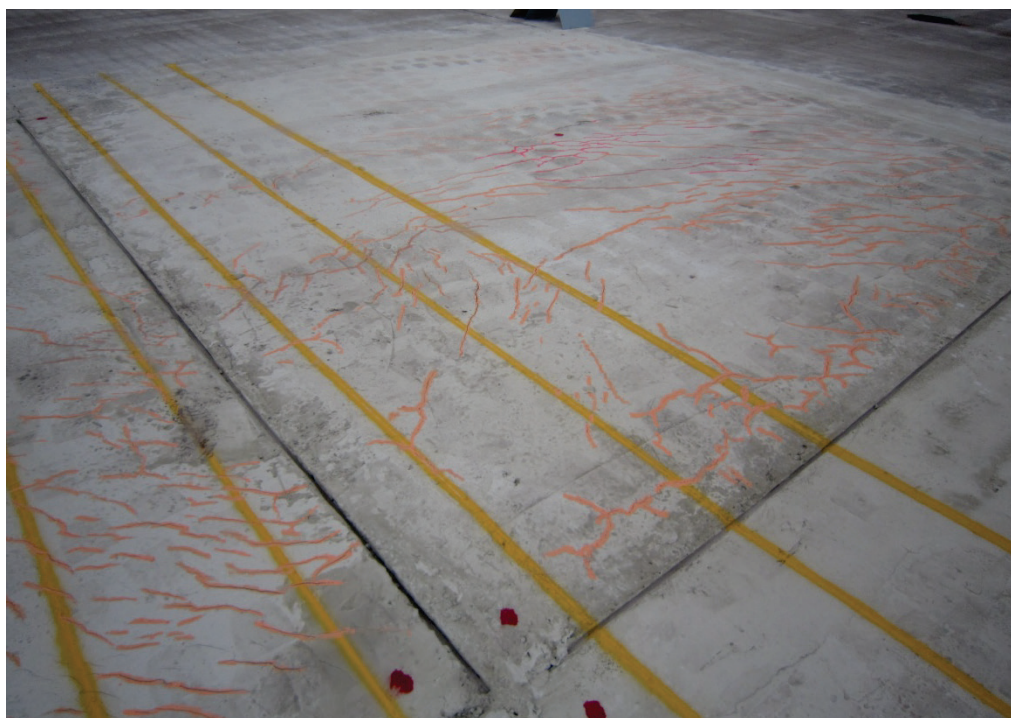
Figure 58 displays the west quadrants of Crater 3, and Figure 59 shows the east quadrants. Both western quadrants contained a considerable amount of shrinkage cracking. Also, the south edge of the southwest quadrant was not square due to damage sustained to that edge during excavation. The eastern quadrants both contained a substantial amount of shrinkage cracking. Figure 60 shows the large amount of shrinkage cracks in the northeastern quadrant.

Figure 60. Crater 3, northeast quadrant, finished repair.
